April 2023

Trima Accel® Automated Blood Collection System Software Version 7.1 Release

Attachment A: New Alerts With Software Version 7.1

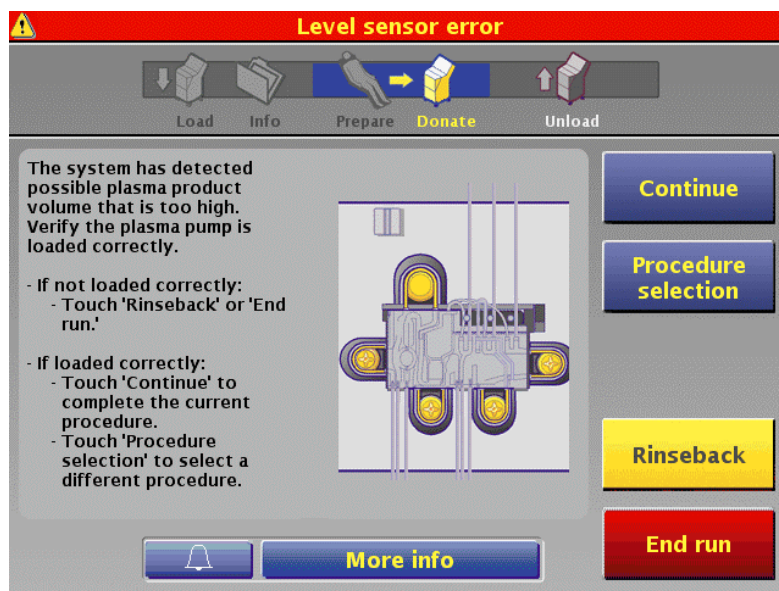
Level sensor error alert: When the system detects a possible plasma volume overcollection, the level sensor error alert is displayed. The system alerts the operator to verify the tubing set is loaded correctly. If it is loaded correctly, the operator can choose to continue or end the procedure.

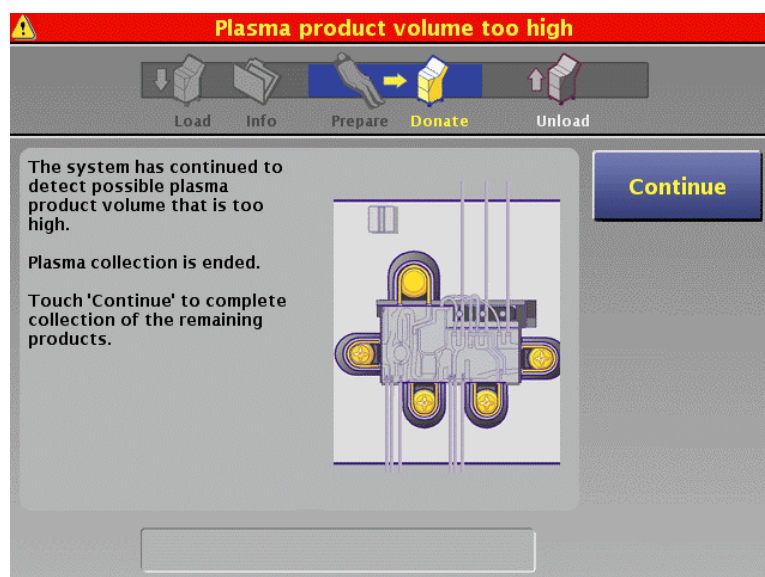
Plasma product volume too high alert: If the operator continues with the procedure from the Level sensor error alert and the system continues to detect plasma overcollection, the notification is displayed. Plasma collection ends, and the system continues collecting the remaining products and then transitions to rinseback.
