**Trima Accel® Automated Blood Collection System**

**Trima-032**  
**Version 7.0.4 Software Release**

This service message announces the release of Trima V7.0.4 software and the associated spare parts.

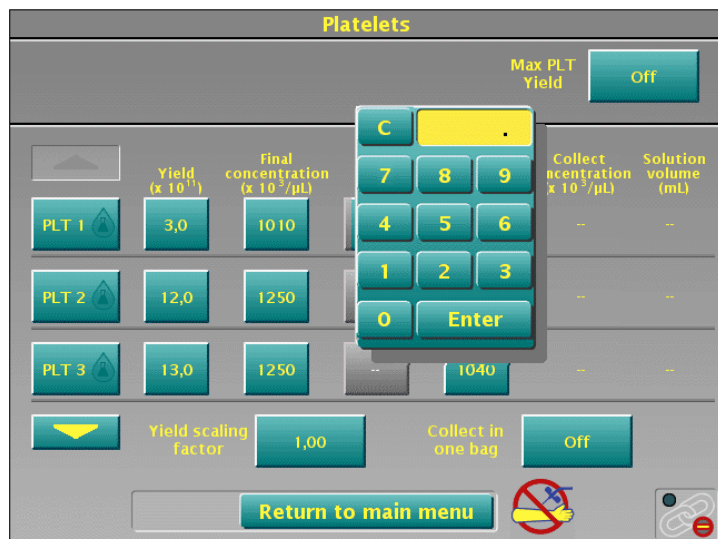
3. Enter the value using the keypad, then press **Enter**.
